Oceanic Bridge FAQ – Jan. 2012

Monmouth County's Oceanic Bridge (S-31) over the Navesink River is closed to motor vehicle, bicycle and pedestrian traffic for repair work to rehabilitate the bridge's 100-foot, center bascule span.

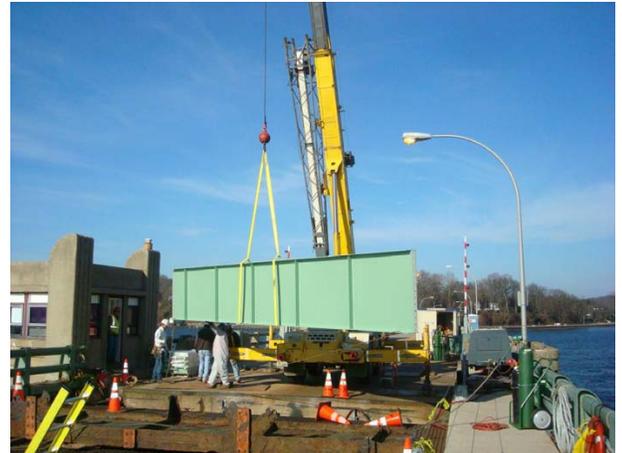
In December, the contractor removed and replaced two major floor beams on the north leaf of the bascule span and reinforced the east and west girders. The contractor also completed the installation of a temporary platform on the south leaf's bascule in preparation of rehabilitation of that span.

On the north leaf, approximately 95 percent of the existing components have been cleaned and primed; some areas have also been painted. Painting work has been stopped for the winter and will resume when structural repairs, stringer and grating deck installation are completed. During the cleaning process, 10 55-gallon drums of rust and paint chips were removed from the north and south spans.
